| Serial Number: UTU-072898_01 | | West Desert District | | Fillmore Field Office | |
| Operator: Amnor Energy | | Project Name: Coyote Knoll Mine | | | |
| Location: Section 05, T012S, R06W, Salt Lake Meridian | | | | | |
| Inspector: Duane Bays | | | Date of inspection: 09/04/2012 | | |

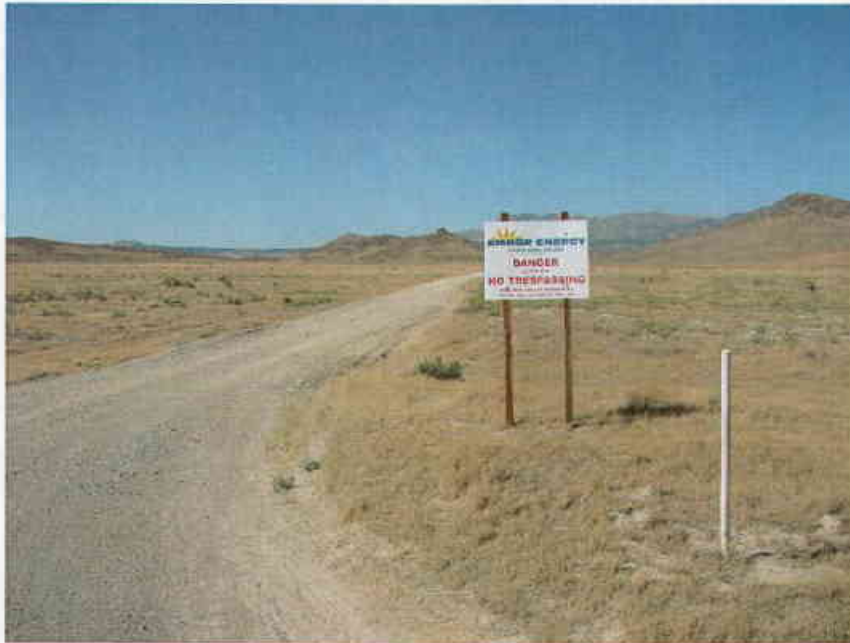
Photo 1. This northward view shows a warning sign at the entrance road to the site. The elevation at the photo point is 1558 m (5110 ft.). The UTM Zone 12 NAD 83 coordinates are: 368410 E 4405789 N

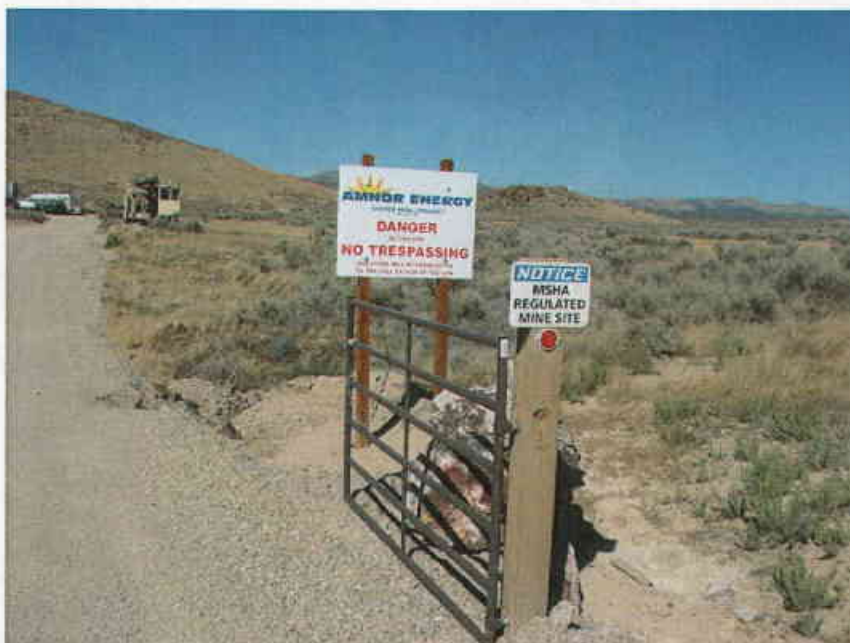
Photo 2. This photo shows a pair of warning signs at the gate to the mine location. This gate has been reported previously as locked, but a locked gate seems appropriate for an active mining site.

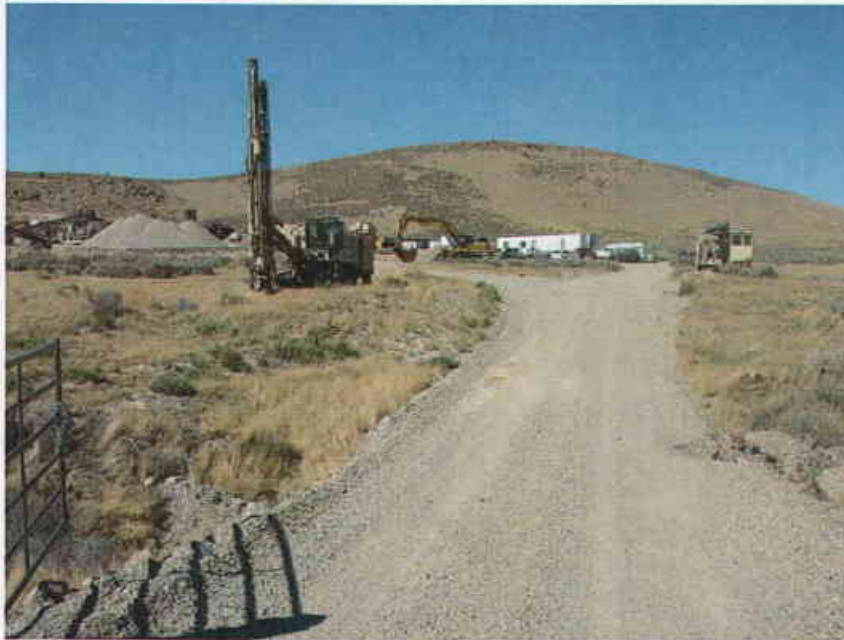
Photo 3. This view from the gate location shows several pieces of heavy equipment and the white office trailer. The measured elevation at the photo point is 1563 m (5110 ft.). The UTM Zone 12 NAD 83 coordinates are:

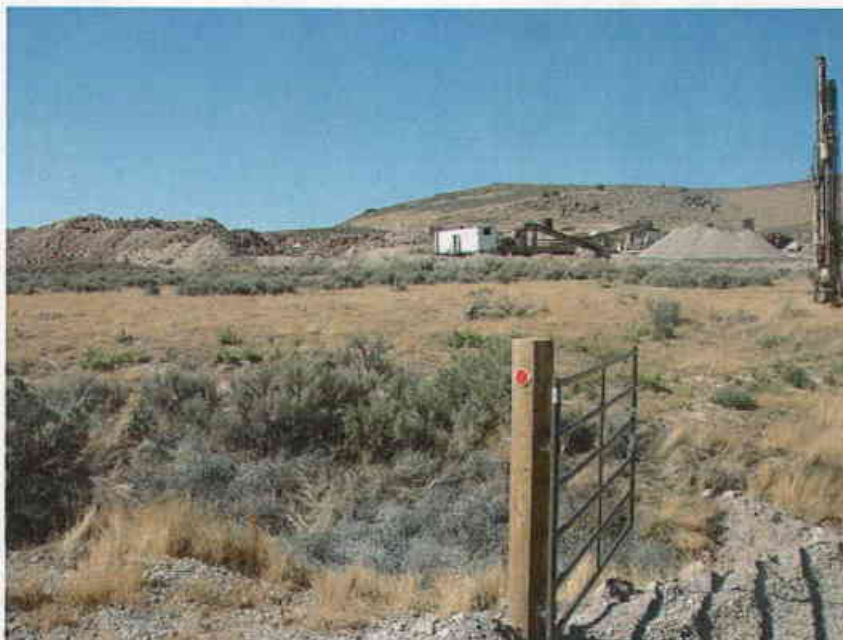
Photo 4. This view, also from the gate location, shows additional equipment, including crushing equipment and a conveyor, and also a waste rock pile.

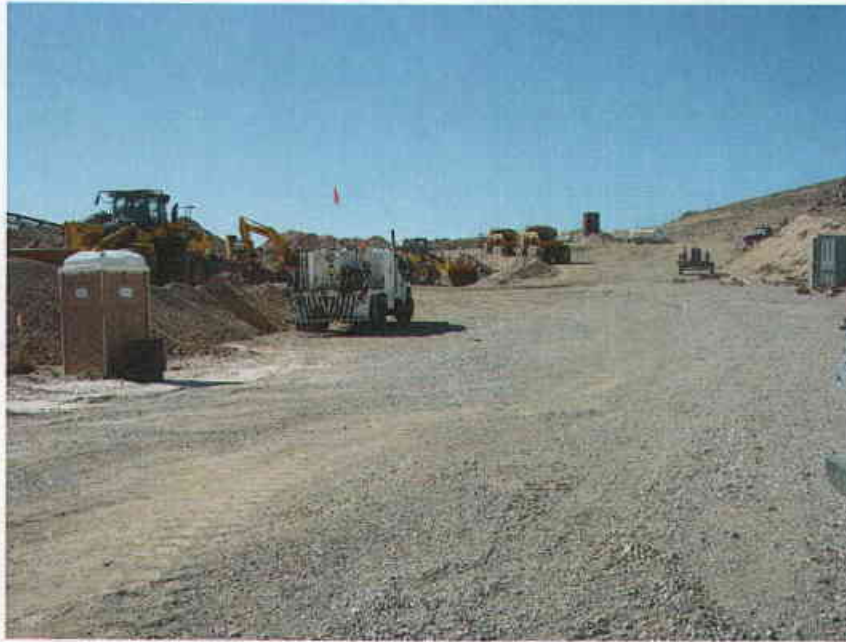
Photo 5. This is a view from the front steps of the office trailer. Note the many pieces of heavy equipment near the pit area. The measured elevation at the photo point is 1569 m (5146 ft.). The UTM Zone 12 NAD 83 coordinates are:

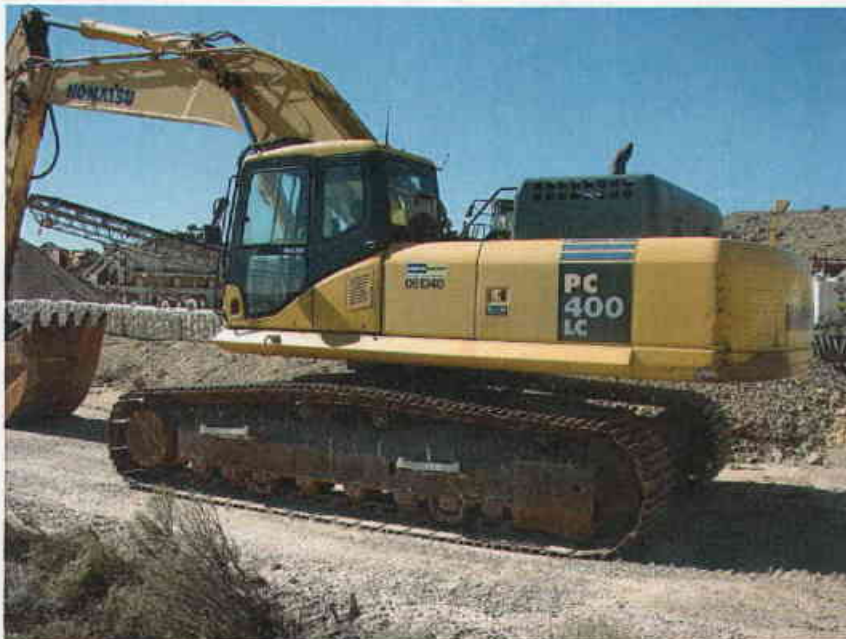
Photo 6. This power shovel was one of several pieces of excavation equipment at the site.

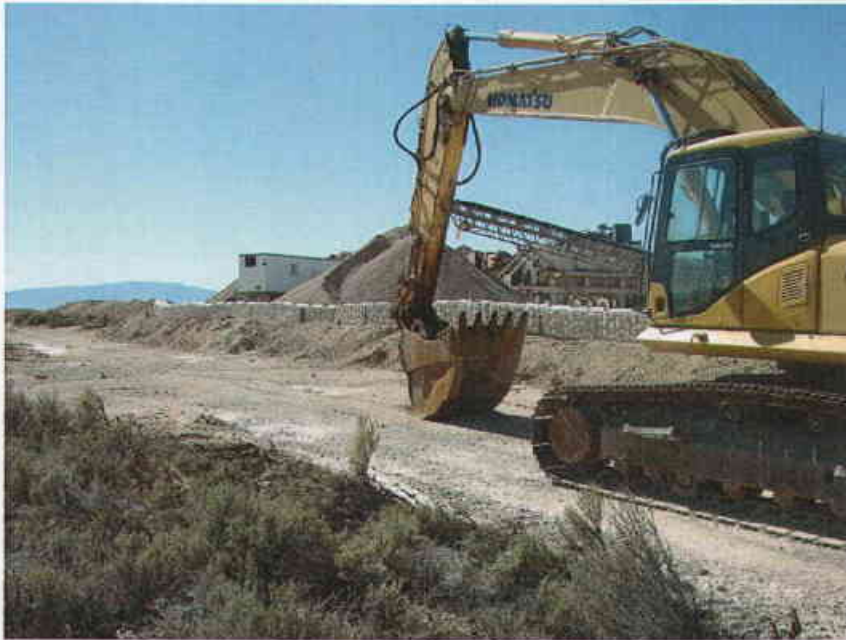
Photo 7. This view beyond the power shovel shows a pile of crushed rock, presumably mineralized material, and a conveyor belt.

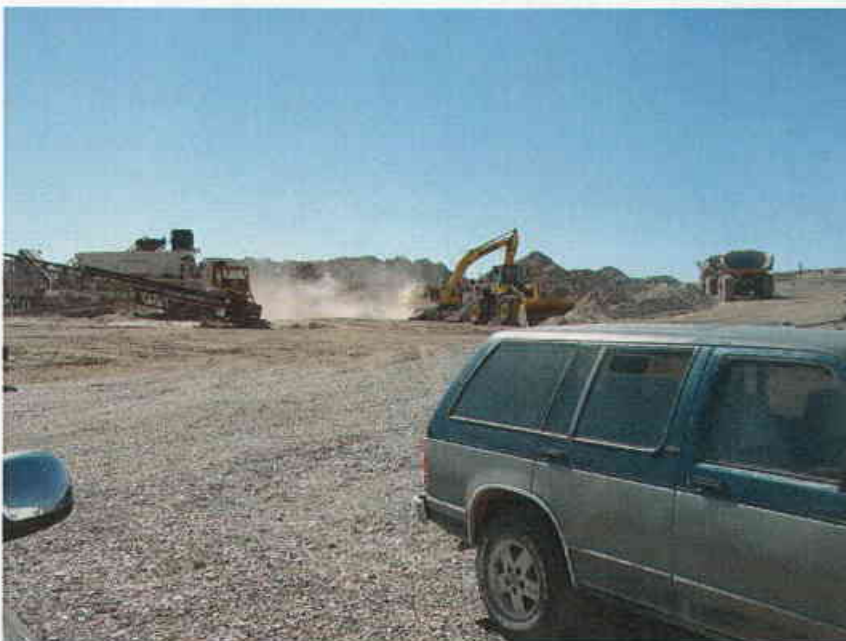
Photo 8. This westward view from the office trailer area shows active loading in progress.

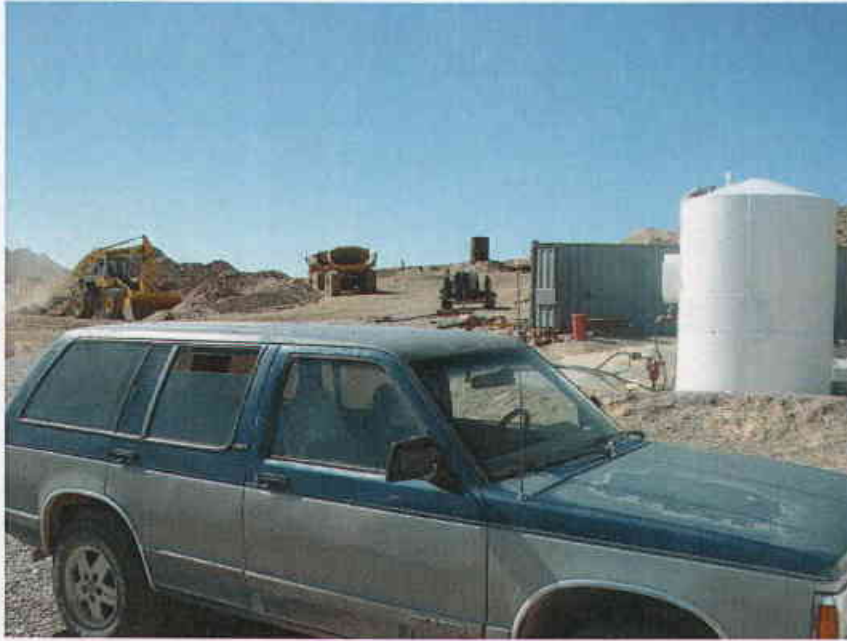
Photo 9. This view shows another perspective of the active operations in the pit area. I did not determine the contents of the white tank. Since there is no perennial water nearby, water must presumably be brought to the site.

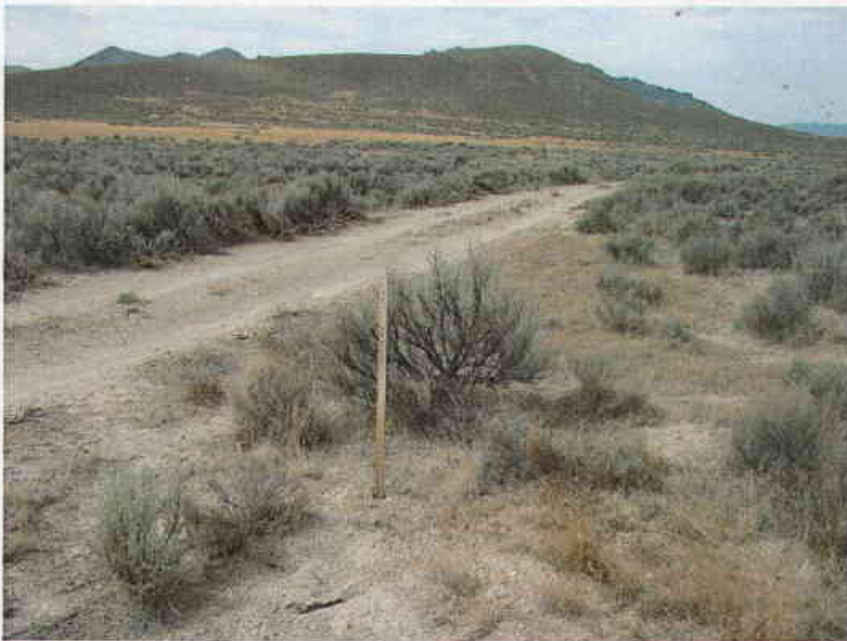
Photo 10. This photo shows a survey stake near the southern margin of the site. The two-track road was not included in the measured surface disturbance area during this inspection.

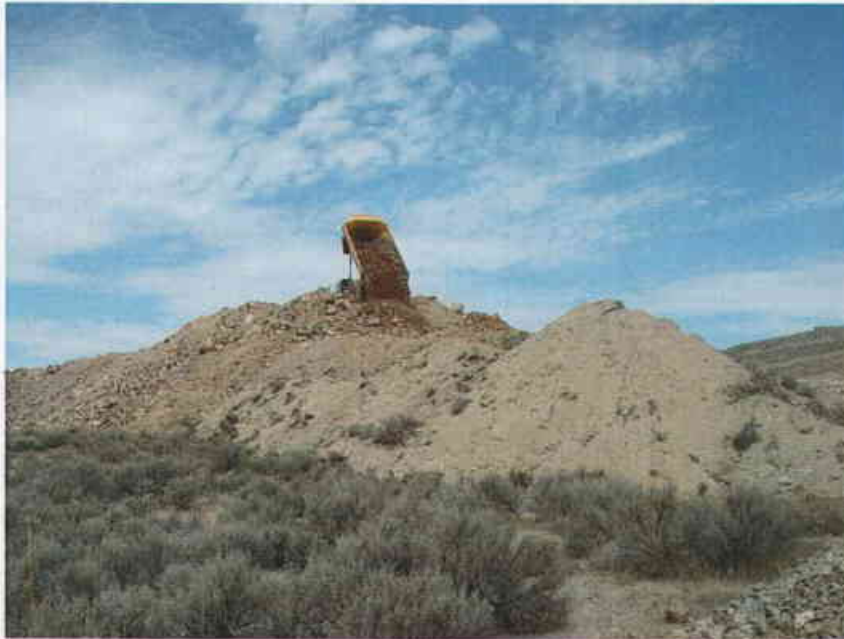
Photo 11. This view shows a truck actively dumping a load of waste rock. The viewpoint faces northwestward.

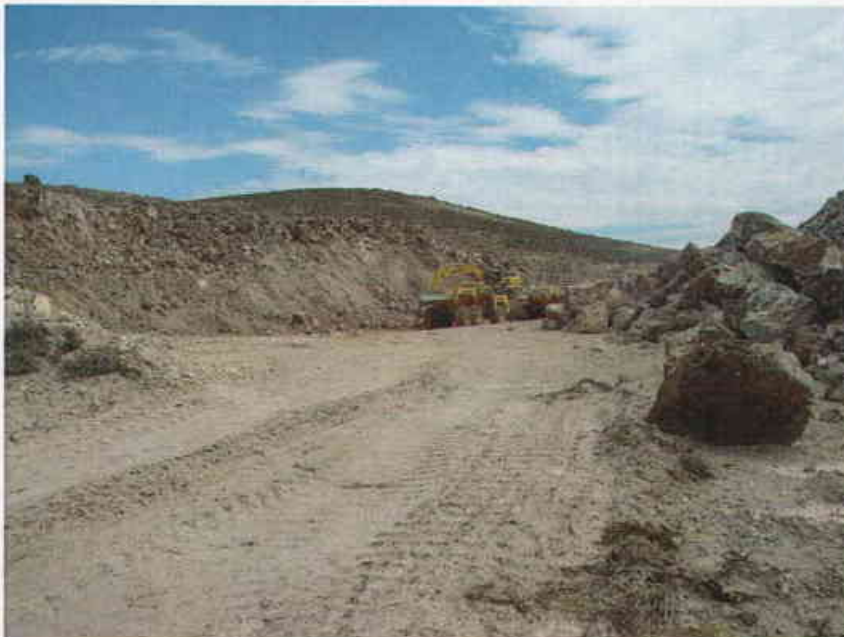
Photo 12. This view faces eastward into the active pit area. Loading of trucks was in progress at the time of the photo.

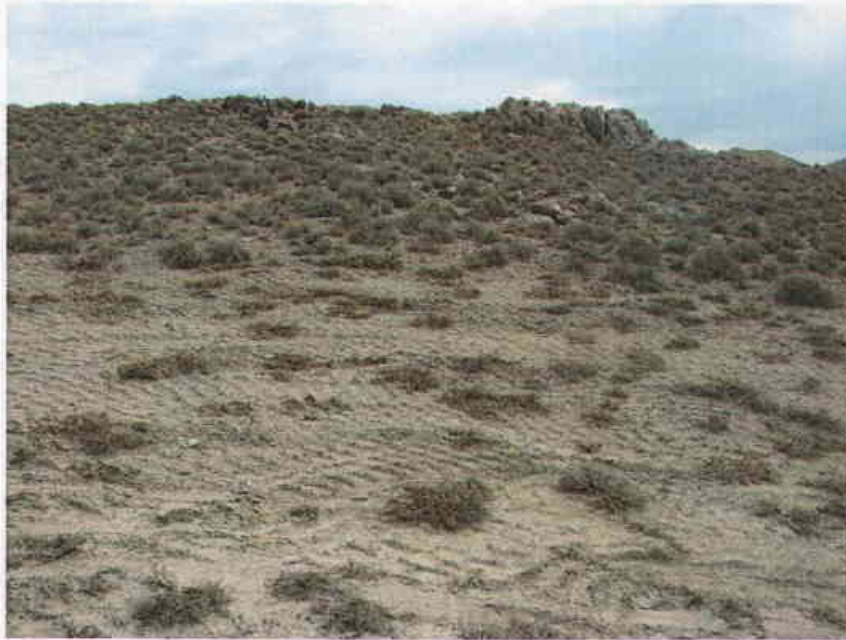
Photo 13. This photo shows an area within the measured surface disturbance area that has not yet been completely stripped of vegetation. The active pit area is immediately beyond the horizon in this photo.

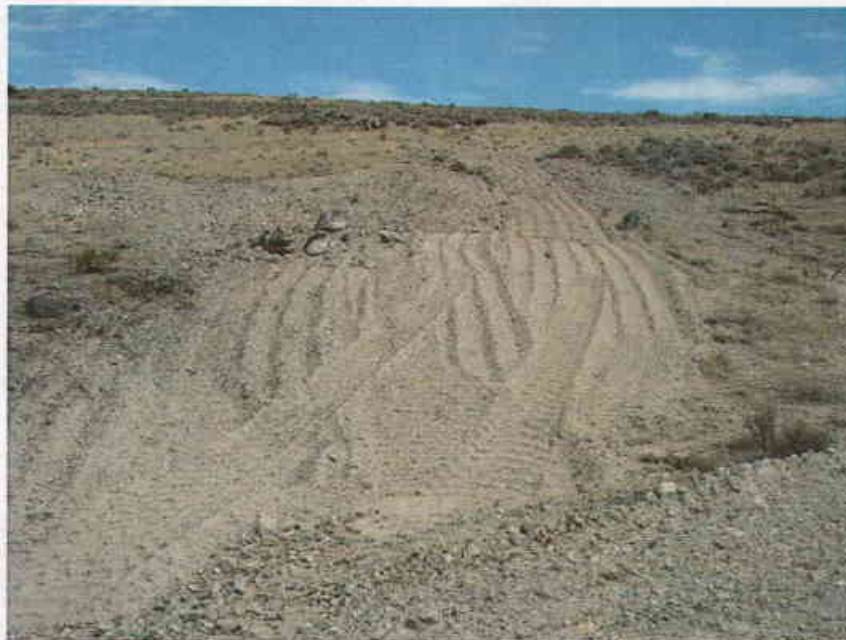
| Serial Number: UTU-072898_01 | | West Desert District | | Fillmore Field Office | |
|---|---|---|---|---|---|
| Operator in conformance with Notice/Plan requirements (Y/N) No – acreage exceeds current allowance | | | | | |

Photo 14. This disturbed area is outside of the delineated surface disturbance perimeter. The viewpoint faces northward. I later determined that this location is within about 100 feet of a State section.

| Serial Number: UTU-072898_01 | | West Desert District | | Fillmore Field Office | |
|---|---|---|---|---|---|
| <p>Instructions to operator: The operator must submit an adequate Financial Guarantee (bond) before conducting any additional surface-disturbing operations. The operator does not appear to have submitted a complete bond for the extent of operations on this date.</p> | | | | | |
| <p>Recommended actions: Confirm that the operator has exceeded allowed surface disturbance at this time. If disturbance has exceeded allowed acreage, then the operator is in noncompliance, probably with both Federal and State of Utah regulations. Management will be advised to consider a Notice of Noncompliance (NoN), a Suspension Order, or both.</p> | | | | | |

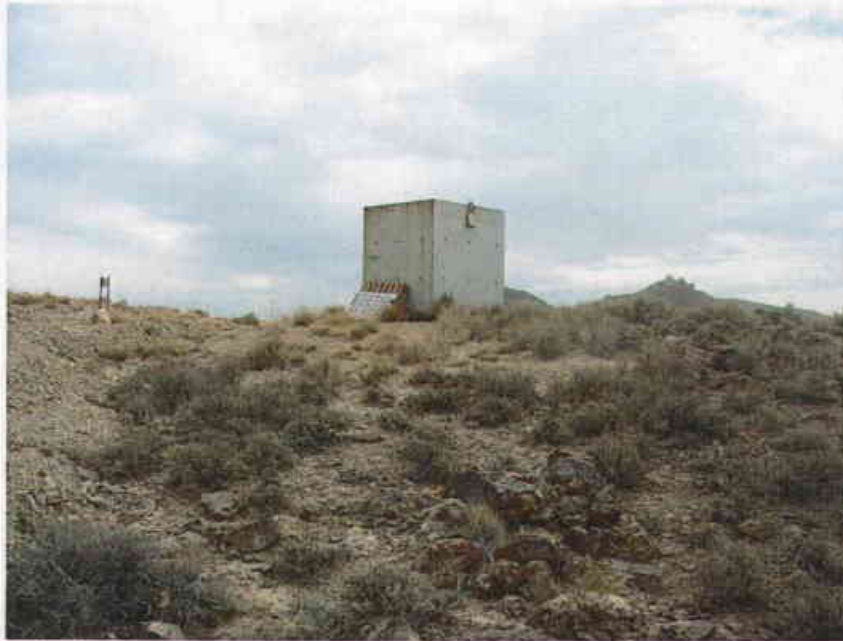
Photo 15. There were two explosives lockers present to the north of the pit area on the date of the inspection. This view faces southward.

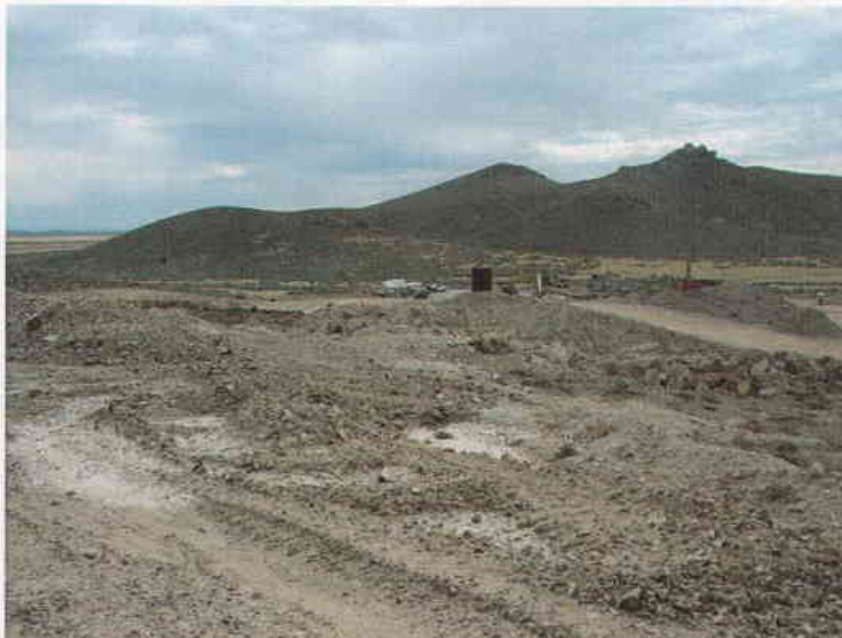
Photo 16. This southward view shows more of surface disturbance area within the perimeter.

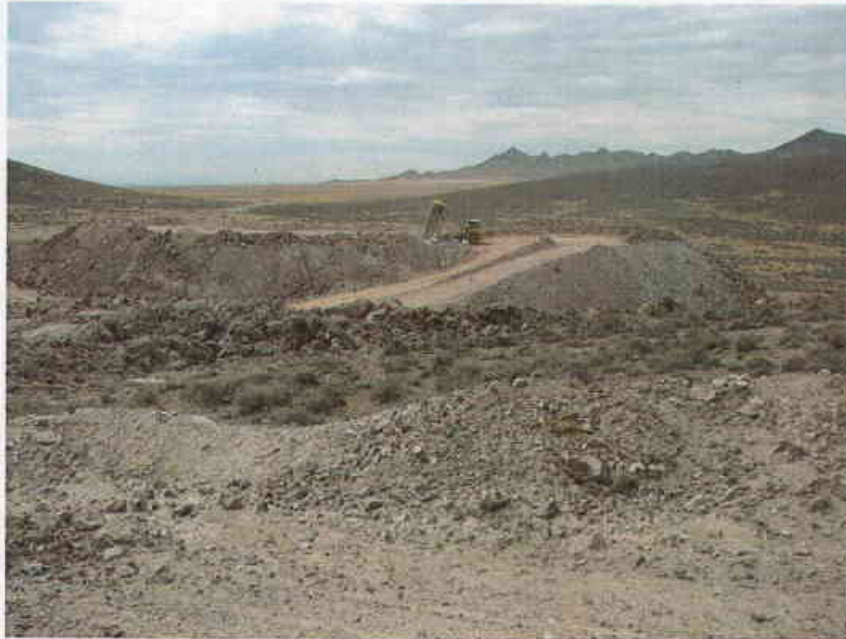
Photo 17. This southward view shows more dumping operations atop the waste rock pile.

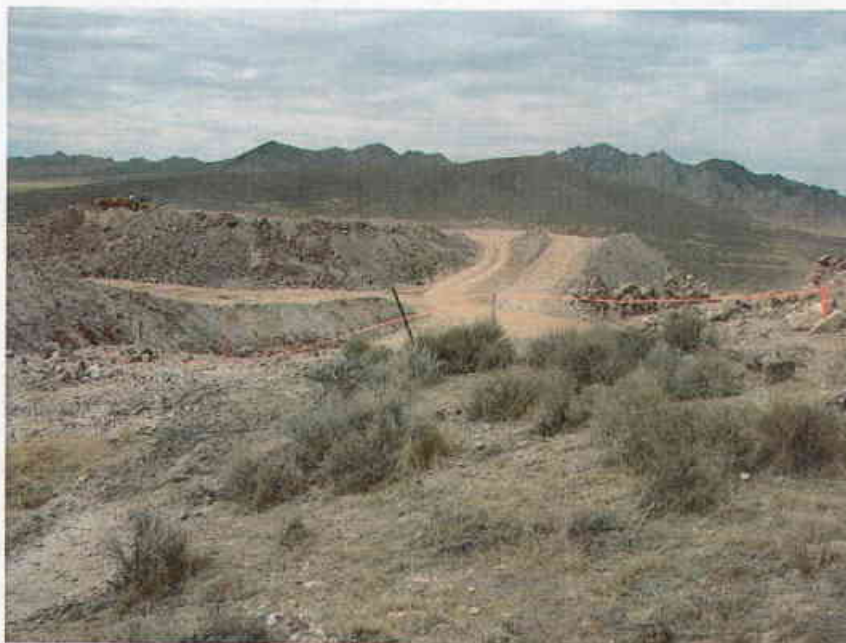
Photo 18. The waste rock pile was very large on the date of this inspection. I did not attempt to measure its height, but estimate it as at least 40 feet.

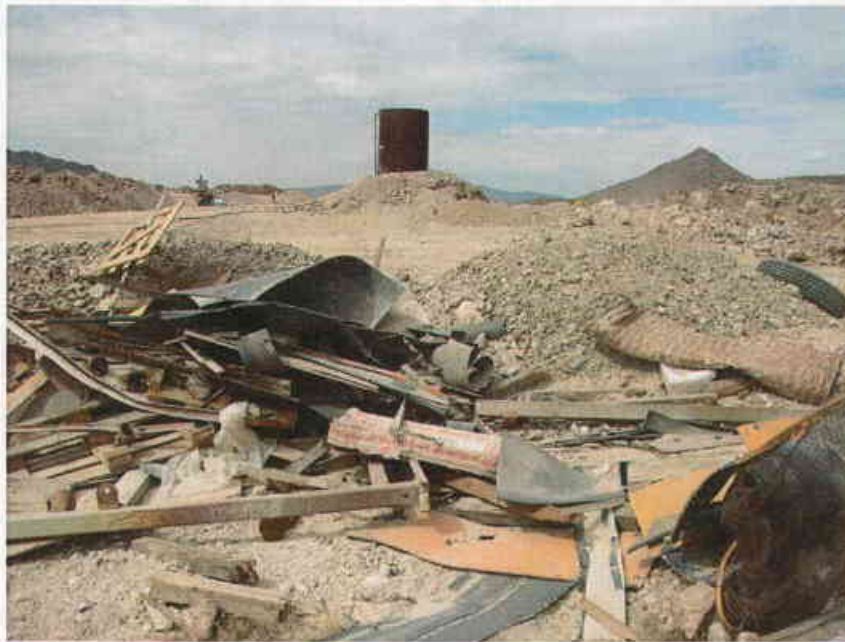
Photo 19. This pile of debris was near the eastern edge of the active mining area. This trash pile is typical of an active mining operation in progress, of course.
